Bill Coons FAA Aviation Safety Counselor....Great lakes Region.

RAISE TAIL (DUAL FORK) SPACERS MLG 2117-87-1
 SS33226-1/-15

1946 ERCOUCPE MODEL-D

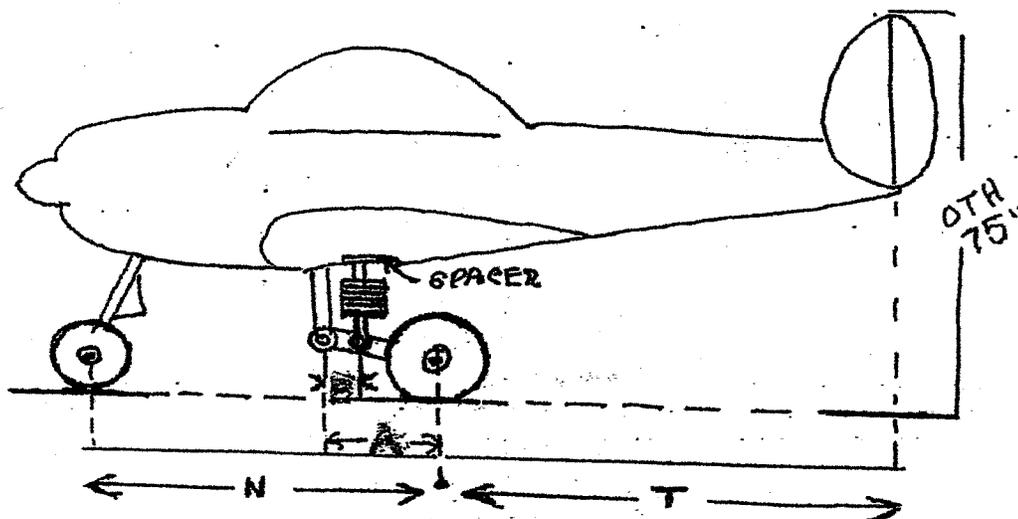
SPACER FORMULA.....ADDITION TO 337 FOR RAISING THE TAIL TO 75 INCHES>>>>

$$\text{SPACER WIDTH } W = \frac{\text{OTH} - \text{TH}}{\frac{A}{B} \times \frac{N+T}{N}}$$

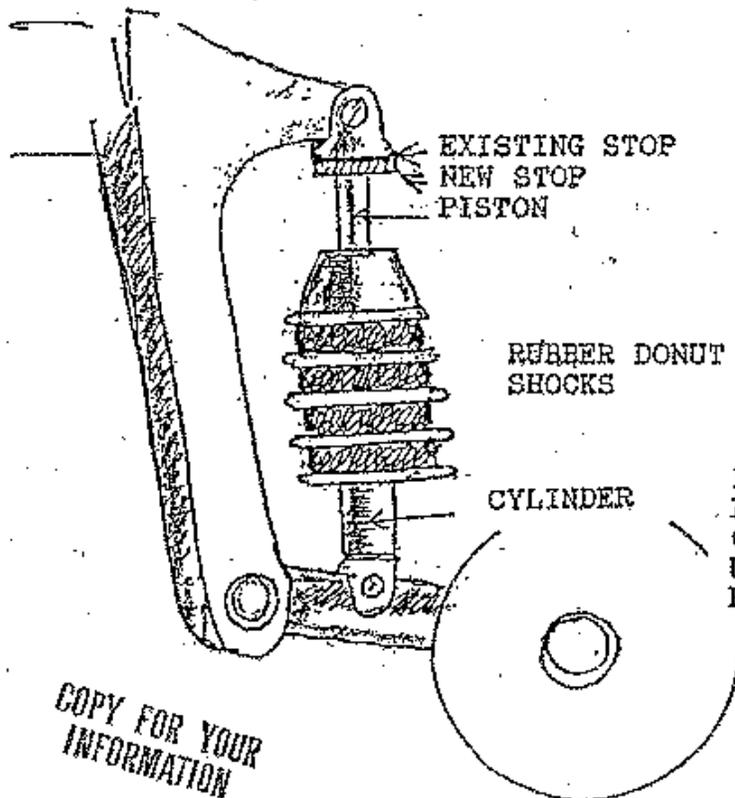
MAIN LANDING GEAR....

THE NEW STOP IS A 7/16
STEEL BUSHING...

ERCOUCPE THAT HAVE A DUAL NOSE FORK NOSE GEAR SUFFER FROM A TAIL LOW CONFIGURATION AND THE AIRPLANE SITS ON THE GROUND AT A POSITIVE ANGLE OF ATTACK. THE TAIL SHOULD BE RAISED SO THAT IT IS AT A NEGATIVE ANGLE OF ATTACK. THE ADDITION OF A 7/16 INCH BUSHING AROUND THE PISTON CREATES A NEW STOP WHICH WILL RAISE THE TAIL BY 10 INCHES. THIS ENHANCES THE GROUND HANDLING QUALITIES OF THE AIRPLANE AND PUTS THE ERCOUCPE BACK INTO DESIGN SPECIFICATIONS, AND RESTORES ALL OF THE SAFETY FEATURES THAT THE ERCOUCPE IS FAMOUS FOR. THIS ONLY MODIFIES THE GROUND HANDLING QUALITIES AND DOES NOTHING TO THE FLYING CHARACTERISTICS.

REMOVE SHOCK ASSEMBLY AND
PULL THE PISTON OUT OF THE
CYLINDER. SLIDE THE BUSHING
UP OVER THE PISTON AND
REASSEMBLE THE SHOCKS..
